MILLPWR^{G2} SOFTWARE UPDATE

February 3, 2017
MILLPWR^{G2} 2 & 3 Axis
Release of Version R4SP5

For Use with Consoles (ID# 745604-NN) ONLY

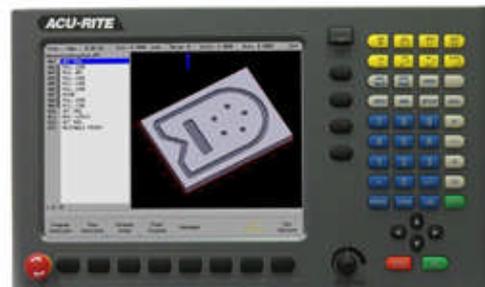
Console ID # 1113777-NN

G2 consoles (ID#1113777-NN)

- **R5 cannot be installed unless you have R4SP4 installed first**. If you have previous version of software such as R1, R2, or R3 SPx (release 1, release 2, or release 3 with any service pack) download and install R4 SP4 prior to updating to R5.

- Due to the enhanced features of release 5, it has become necessary to restructure the console's hard drive. USB Recovery Drive ID# 680480-04 is now included in Recovery Drive Kit ID# 1127022-01 which supports all G2 consoles and all software versions to date or planned for the near future. This new recovery drive includes an option for resizing the control's hard drive partitions. This must only be performed on current consoles (ID#1113777-NN) that are running software release 4 service pack 4 (R4 SP4). Please insure the console is updated to this release prior to restructuring the drive and installing release 5 (R5). Hard drive restructuring is required on these consoles prior to the upgrade to release 5 (R5).
