# MILLPWR<sup>G2</sup> SOFTWARE UPDATE

June 19, 2017  
MILLPWR<sup>G2</sup> 2 & 3 Axis  
Release of Version R4SP6

**For Use with Consoles (ID# 745604-NN) ONLY**

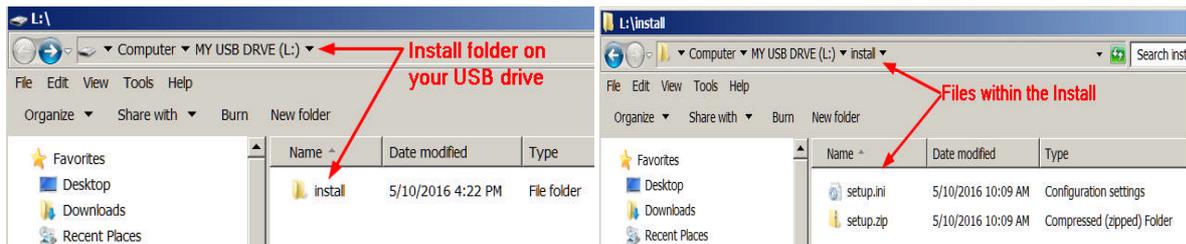
- Unzip the downloaded archive insuring the target is the root level of your USB drive.
- Insure the files setup.zip and setup.ini are transferred to a folder at the root level of your USB drive named install, //MY USB DRIVE/install/

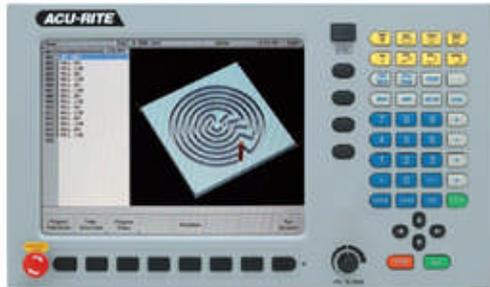
Console ID # 745604-NN

- Due to hardware differences the original MILLPWR<sup>G2</sup> console and the current console require different software upgrade paths.
- Consoles can easily be identified by the color of the front bezel. The current design has a darker grey color than the original design.
  - The current G2 console will proceed to release 5 (R5) and all its service packs.
  - The original G2 console will remain with release 4 (R4) and all of its service packs.

- System drive restructuring on this original design consoles will cause the console to become un-operational and require in house service to correct the issue. **Do not restructure the drive on these consoles.**
